Watervliet Arsenal
Barracks
(Building 24, Operations Directorate Office)
Arnold Lane south of Westervelt Avenue
Watervliet
Albany County
New York

HISTORIC AMERICAN BUILDINGS SURVEY

HABS No. NY-5521G

(Building 24, Operations Directorate Office)

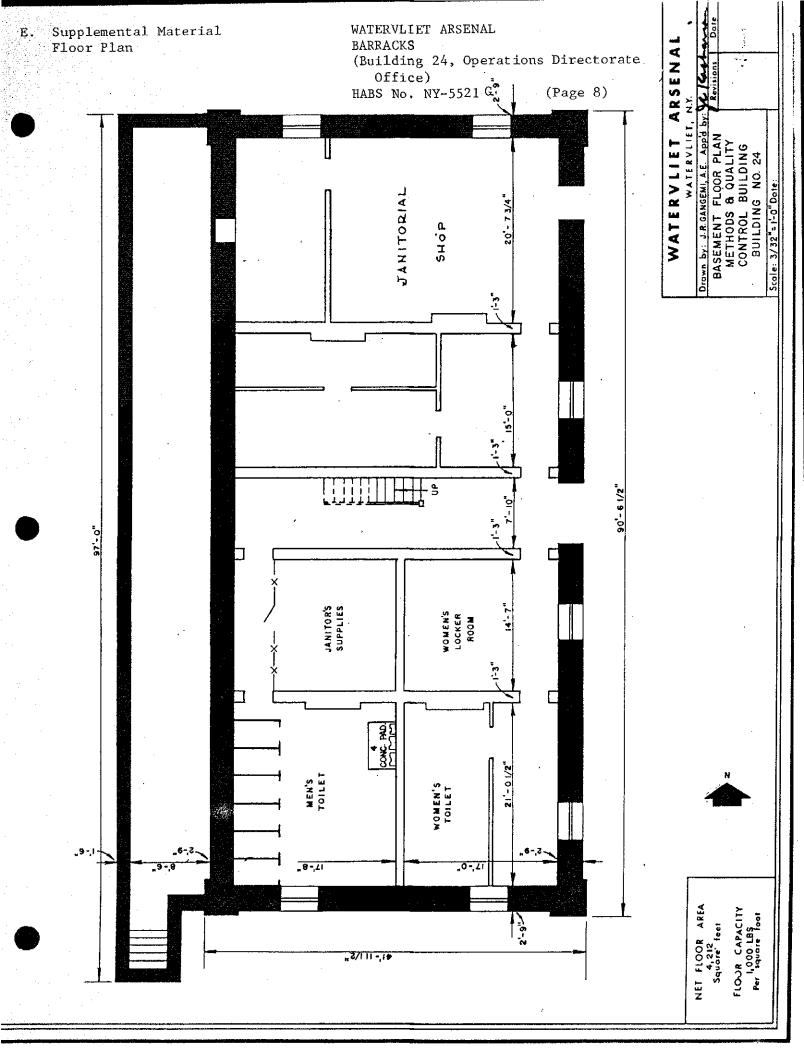
Basement, First, and Second Floor Plans, Building No. 24. No date. 3 sheets. Watervliet Arsenal Engineering Division. Current floor plans of building.

- a. Basement: The basement door at the center of the building opens onto a central hall containing the stairs. Access to the women's locker room and restroom south of the hall and the five rooms north of the hall is through a narrow hall running the width of the building along the east wall. The men's restroom and storage room south of the central hall open off a third hall on the west wall. A long room 8'6" wide extending the full length of the building on the west is entered only from the exterior. (See supplemental material, floor plans)
